Arboricultural Report

Tree Survey,
Arboricultural Impact Assessment &
Arboricultural Method Statement

Lands at Gortnahomna

November 2024

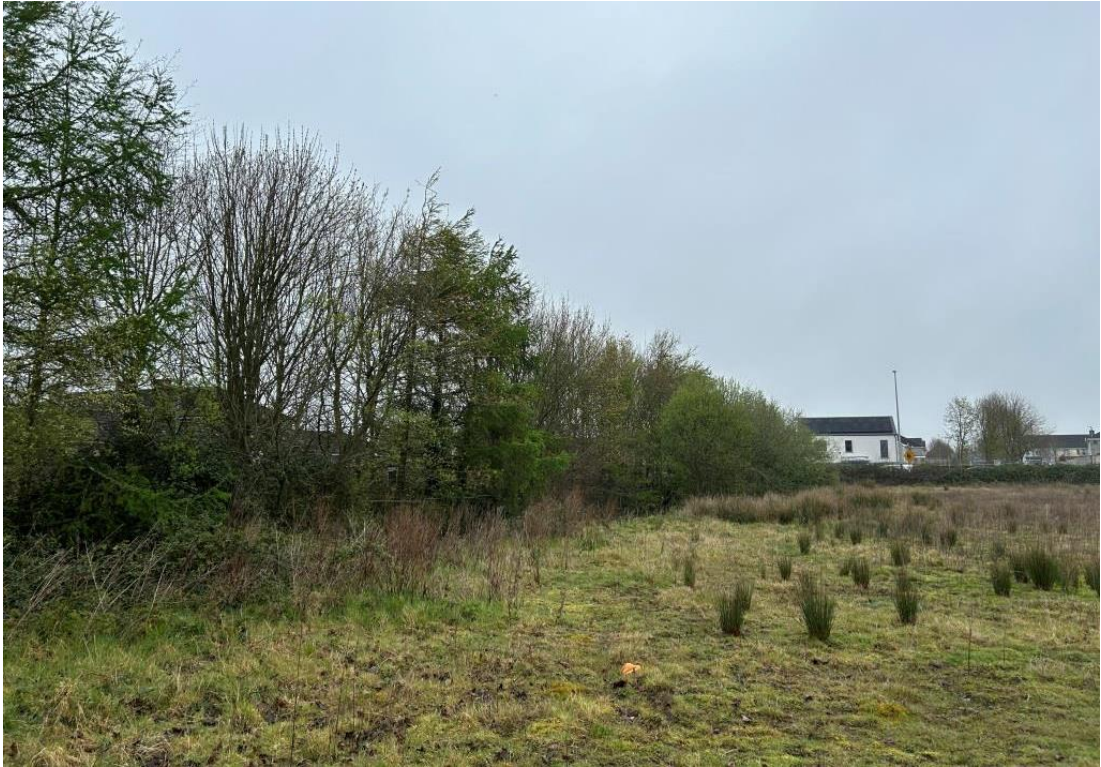
Photo 1: View of the mixed early-mature tree group G62 located along the western boundary adjacent to Cuir Na Greine.

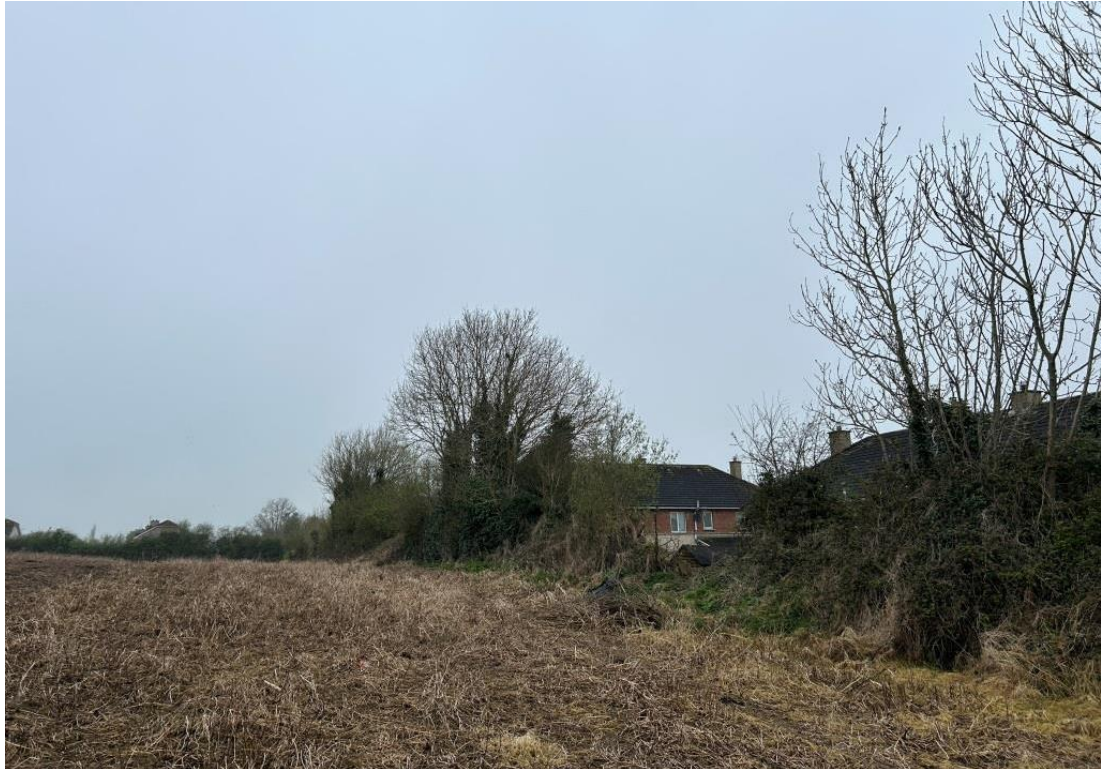
Photo 2: View of the mixed native boundary hedgerow H1 with several lapsed ash coppice trees located adjacent to Cuir Na Greine.

| Tree ID | No. | Species | Height (m) | Stem diameter (cm) | No. of Stems | CROWN SPREAD (m) | | | | | | | | Crown clearance (m) | L.B. (m) | Life stage | Condition Notes | Survey date | RPA (m ²) | RPR (m) | Life expectancy (yrs) | BS Category |
|---|---|--|---|---|---|---|---|---|---|---|---|---|---|---|---|--|---|---|---|---|---|---|
| Hedge H1 | 1 | Sambucus nigra (Elder) | 6.0 | 20 AVE | 1 | | | | | | | | 0.0 | | Mature | Structural condition Fair. Physiological condition Fair. Mixed native boundary hedgerow managed on the field side only. Height was historically managed but has been neglected. There are several gaps within the hedgerow. There are several early-mature lapsed ash coppice trees within the hedgerow. These are generally multiple stemmed with weak unions. A number of the ash are showing symptoms of decline as a result of ash dieback. On the northern side of the hedgerow, the levels have been significantly dropped to construct the residential development. If hedgerow is to be retained, its height should be reduced to approx. 3m and new planting carried out. Height varies from 6m to 12m and stem diameter is average for group. Quantities not recorded, only species mix. | 11/04/2024 | 18.1 | 2.4 | 20-40 | C2 | |

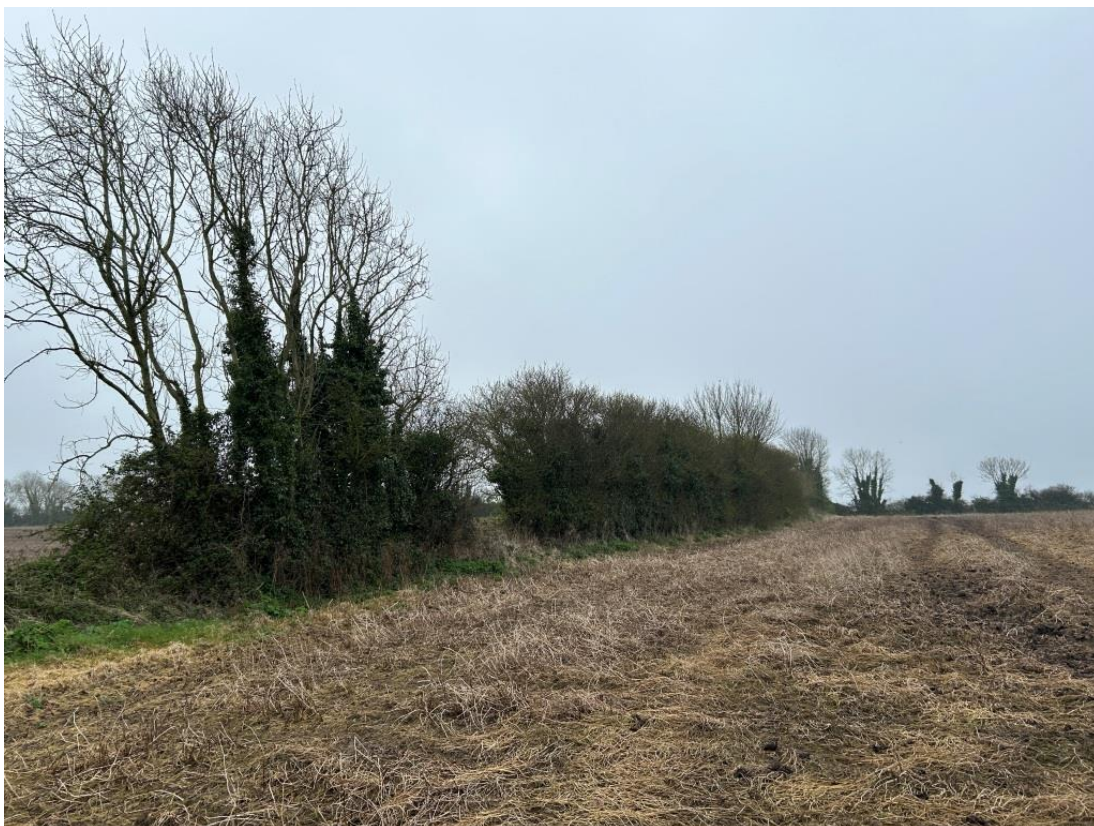
Photo 3: View of the central ash trees and native hedgerow T31 to H37. The ash trees are in poor condition and infected with ash dieback.

- 6.3 The 3 trees recommended to be removed are ash. Their removal is required for good arboricultural reasons as they are all in poor condition and infected with ash dieback. Their retention within the new development is not considered to be suitable.

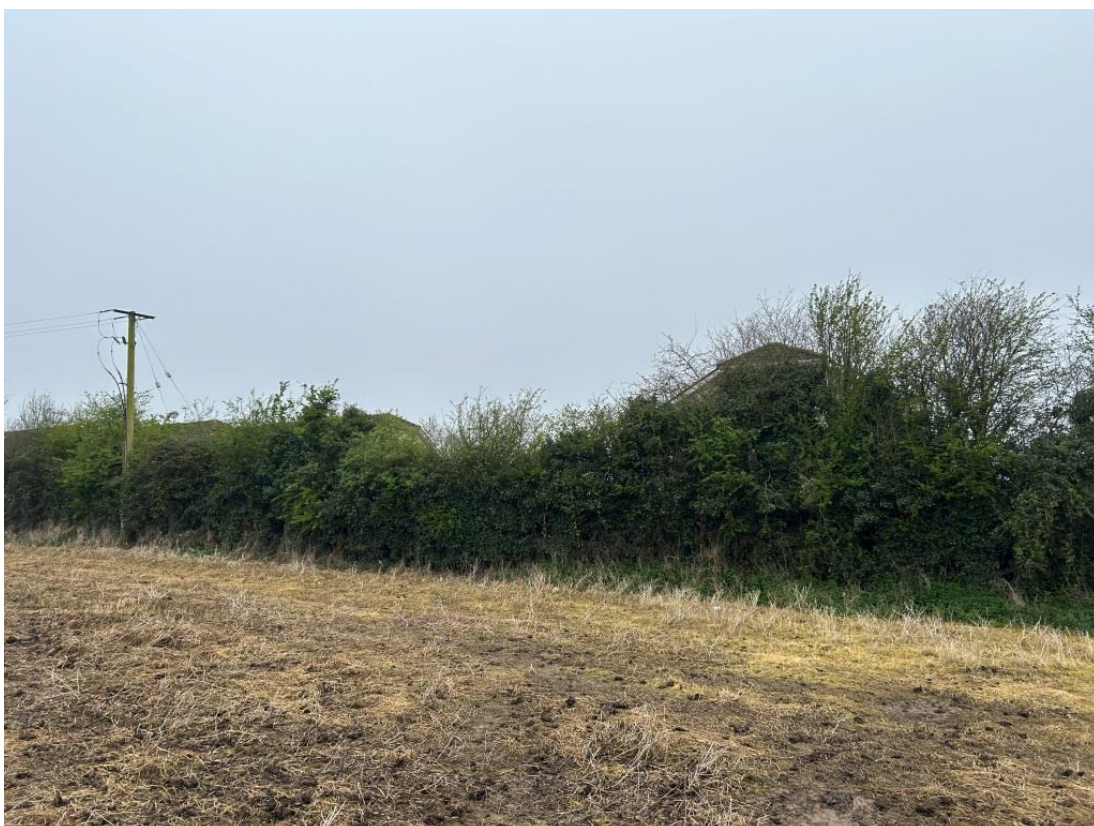
Photo 4: View of the western boundary native hedgerow H2 located adjacent to Castlemanor Crescent. The hedgerow is predominantly hawthorn and has been managed on the field side.

| Tree ID | No. | Species | Height (m) | Stem diameter (cm) | No. of Stems | CROWN SPREAD (m) | | | | | | | | Crown clearance (m) | L.B. (m) | Life stage | Condition Notes | Survey date | RPA (m ²) | RPR (m) | Life expectancy (yrs) | BS Category |
|---|---|--|---|---|---|---|---|---|---|---|---|---|---|---|---|--|---|---|---|---|---|---|
| Hedge H2 | 1 | Sambucus nigra (Elder) | 6.0 | 20 AVE | 1 | | | | | | | | 0.0 | | Mature | Structural condition Fair. Physiological condition Fair. Mixed native boundary hedgerow, predominantly hawthorn, managed on the field side only. Height was historically managed but has been neglected. The main stems of the hedgerow are approx. 1-1.5m back from the boundary wall. A large portion of the hedgerow is densely stocked and in good condition. the southernmost section is of poor quality and mainly bramble. If hedgerow is to be retained its height should be reduced to approx. 3m and new planting carried out along the southern section. Height and stem diameter are average for group. Quantities not recorded, only species mix. | 11/04/2024 | 18.1 | 2.4 | 20-40 | B2 | |

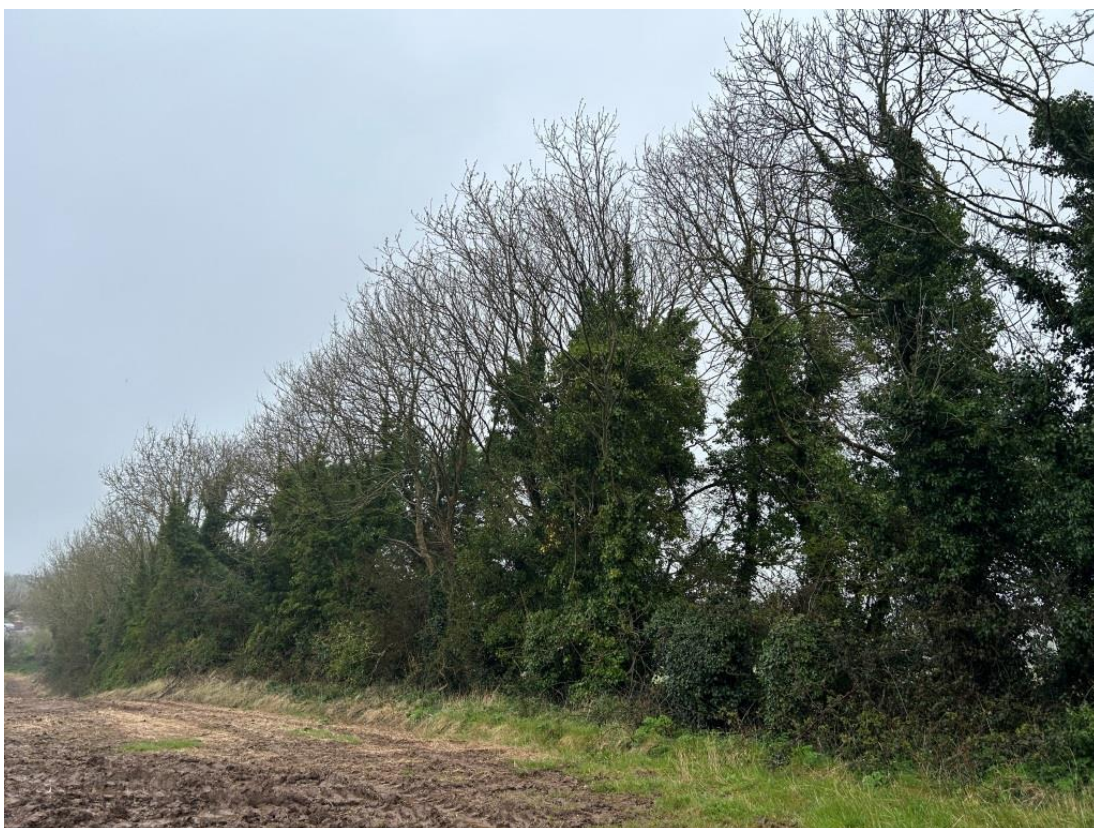
Photo 5: View of the eastern boundary tree group G39. Ash is the dominant species. Several are mature lapsed coppice stools with decay and are showing symptoms of ash dieback.

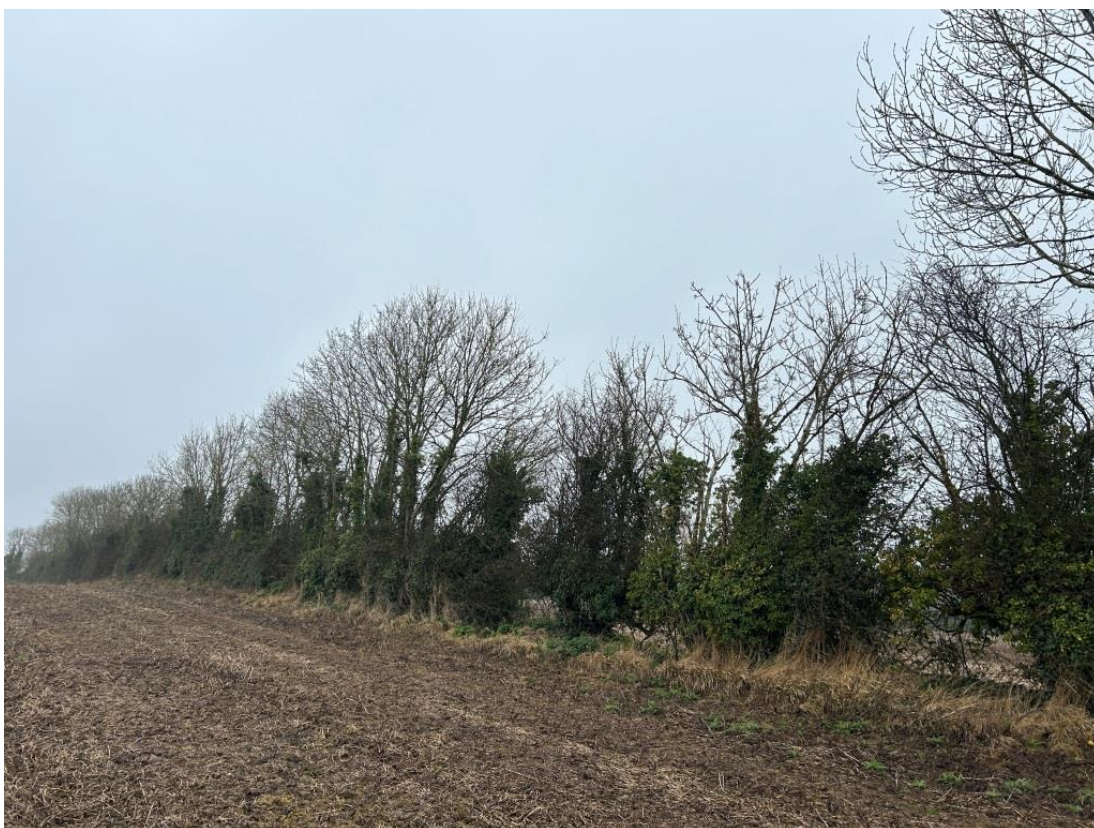
Photo 6: View of the southern boundary tree and hedge line H23. The hedgerow, including the ash trees, were originally managed at 1.5m and have regrown.

| Tree ID | No. Species | Height (m) | Stem diameter (cm) | No. of Stems | CROWN SPREAD (m) | | | | | | | | Crown clearance (m) | L.B. (m) | Life stage | Condition Notes | Survey date | RPA (m ²) | RPR (m) | Life expectancy (yrs) | BS Category |
|---|--|---|---|---|---|---|---|---|---|---|---|---|---|---|---|--|---|---|---|---|---|
| Hedge H23 | 1 Crataegus monogyna (Common Hawthorn/Quick/May) | 7.0 | 25 AVE | 1 | | | | | | | | | 0.0 | | Mature | Structural condition Fair. Physiological condition Fair. Native hedgerow, predominantly ash and hawthorn. Height originally managed at 1.5m but has been neglected and regrowth has lapsed. Ash trees have regrown to a height of approx. 8-12m with multiple stems and weak unions. Several ash also show symptoms of ash dieback. A mixture of C and U Category trees. If hedgerow is to be retained, ash trees will need to be recoppiced to 1.5m and the height of the hawthorn should be reduced to approx. 3m. Height varies from 5m to 12m and stem diameter is average for group. Quantities not recorded, only species mix. | 11/04/2024 | 28.3 | 3.0 | 20-40 | C2 |

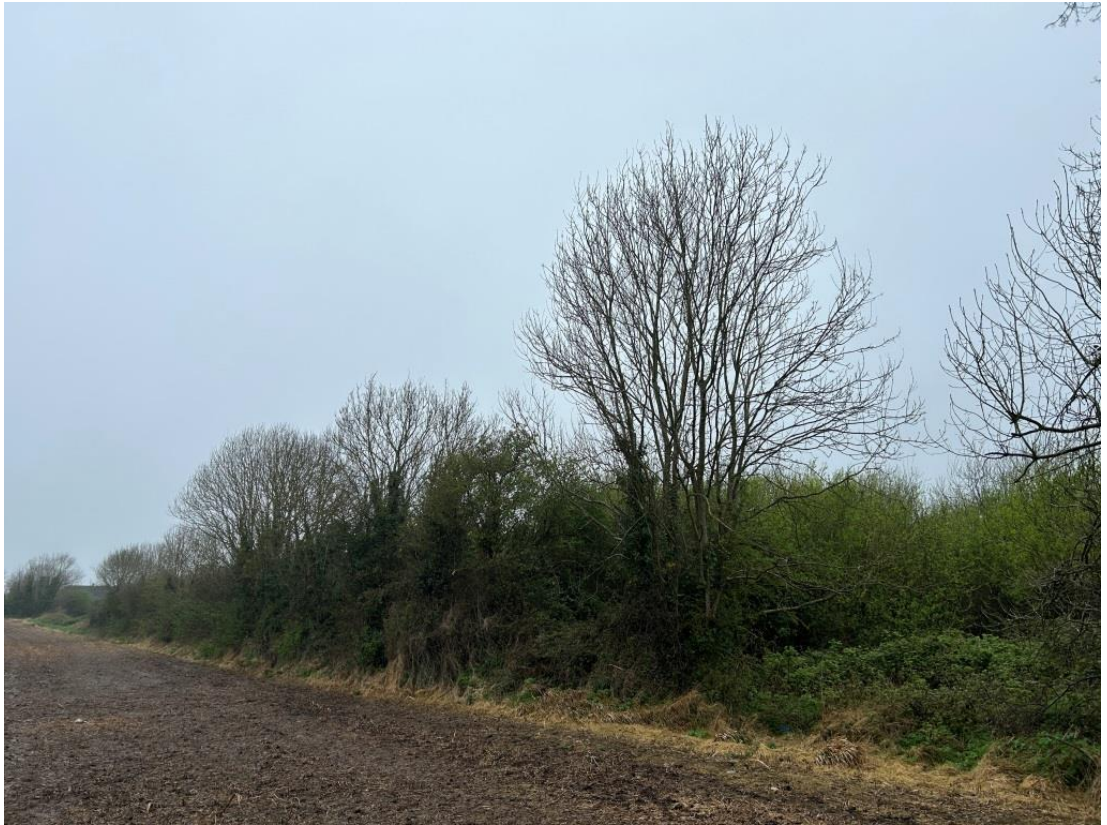
Photo 7: View of the native hedgerow H54 which is predominantly hawthorn with several lapsed coppice stool ash trees.

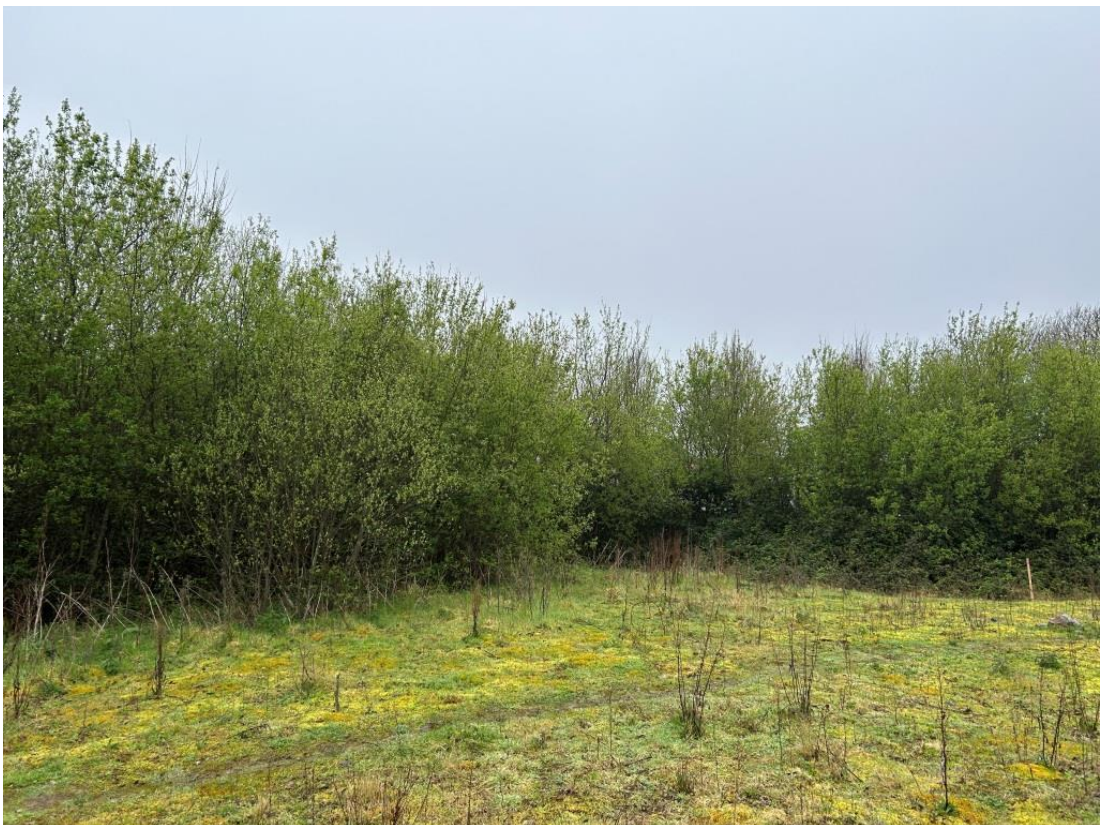
Photo 8: View of the overgrown self-seeded goat willow and bramble (W59).

- 6.4 The 7 low-quality and value tree and shrub groups, which predominantly contain goat willow and bramble, are all located at the front of the site, adjacent to Killeagh Road. Their removal is partially required to facilitate the development but is also recommended for landscape improvement reasons.

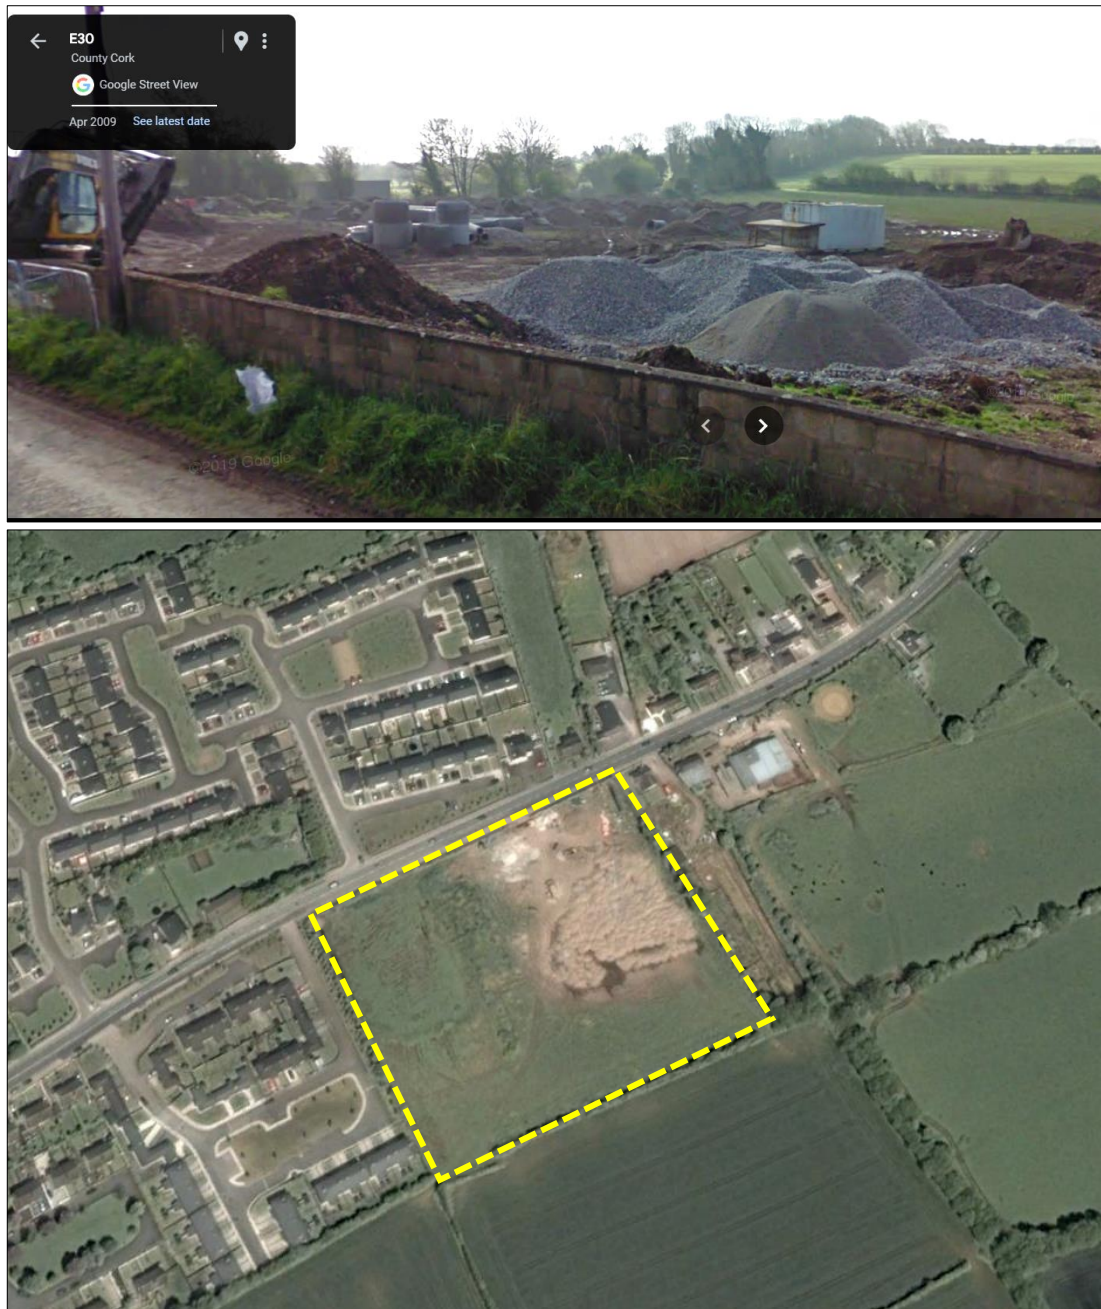
Image 1: Google street view and aerial image showing the northern parcel of land in 2009. At this time, it was extensively used as a site compound and there were no large groups of goat willow and brambles present.
