# Residential Development at Gortnahomna, Castlemartyr Stage 1 Road Safety Audit

Marshall Yards Development Company Ltd.

October 2024

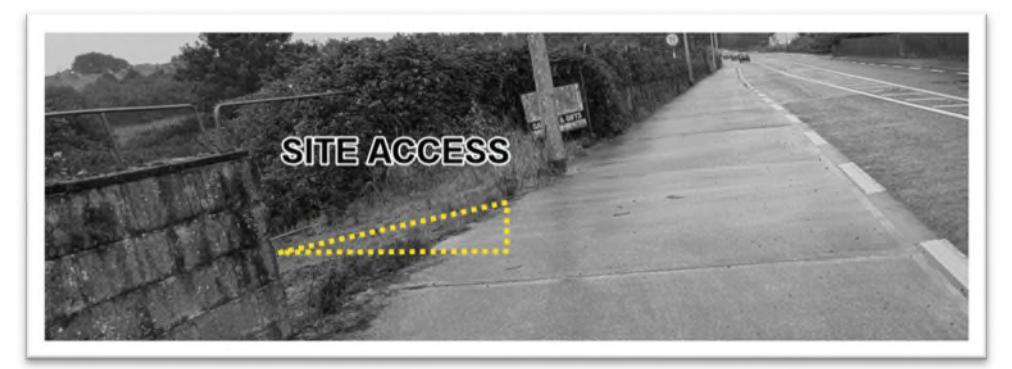
Figure 2.1 – Steep Approach to N25 Could Lead to Vehicle Stalls

#### Location: Main Site Access Road Connection to N25

The unusually steep uphill gradient could lead to vehicles either rolling back or stalling as they attempt to join the N25. This is likely to increase the risk of a collision at the site access.

A suitable dwell area (i.e. a short section of road in advance of the stop line where the gradient has been reduced) should be provided on approach to the pedestrian crossing and connection point to the N25.

Problem Reference (Section 2)	Designer Response Section			Audit Team Response Section
	Problem Accepted ( yes / no )	Recommended Measure Accepted ( yes / no )	Alternative Measures or Comments	Alternative Measures Accepted ( yes / no )
2.1	Yes	Yes	A gradient of 1:75 has been applied to the entrance. The existing site levels will be raised to facilitate this.	Comment noted & accepted.
2.2	Yes	Yes	Larger corner radii have been applied to the horizontal deflections and junction	Comment noted & accepted.
2.3	Yes	Yes	A change in surface material and a pedestrian refuge is proposed. Additional slow zone signs have been added to the home zone entrances.	Comment noted & accepted.

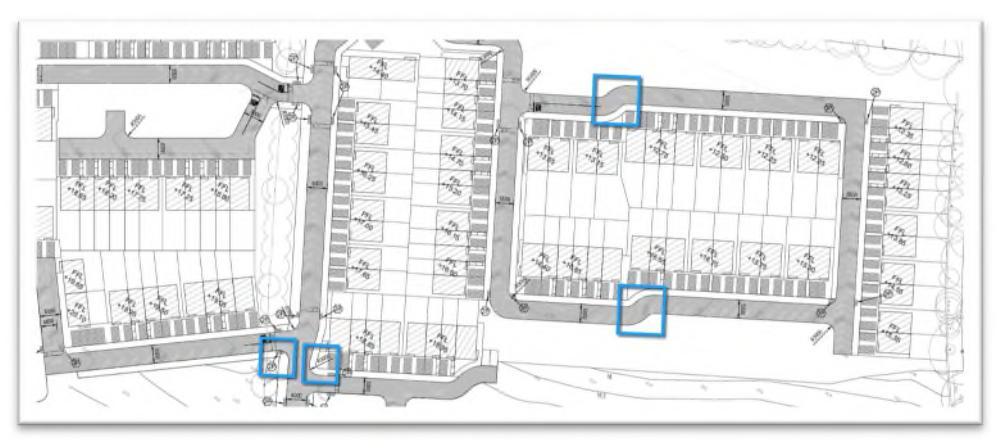
Figure 2.2 – Locations Where Abrupt Turns Could Lead to Driver Conflicts

#### Location: Various Horizontal Changes in Direction on Internal Streets

The abrupt (low radius and sharp) changes in direction could lead to opposition type vehicle conflicts or drivers mounting kerbs.

The abrupt turns should be replaced with more suitable (larger and smooth) horizontal curves.

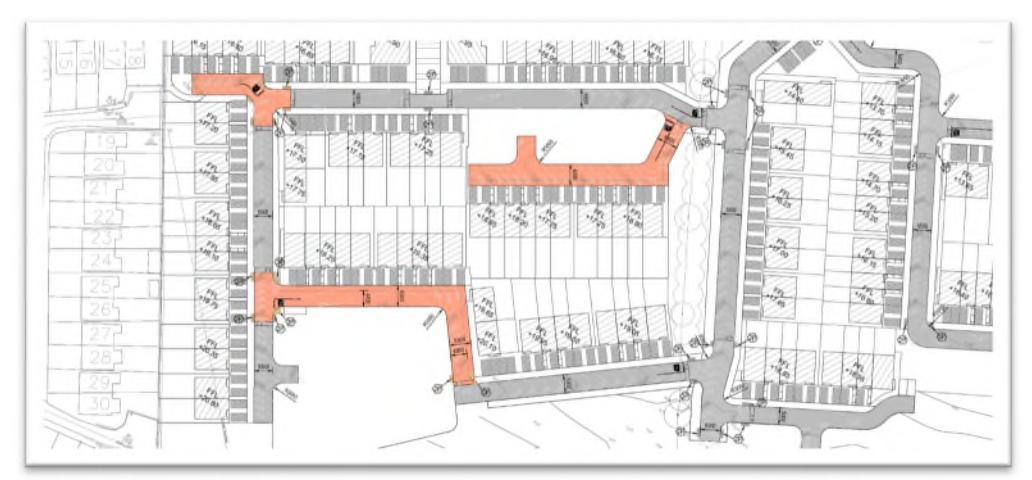
#### Figure 2.3 – Streets Where Vehicles Will Share Space with Vulnerable Road Users

#### Location: All Homezone Gateway Entry Points

It may not be readily apparent to drivers entering Homezone streets that they will be required to give way to pedestrians (including children at play), who will be sharing the road space with them. This is likely to increase the risk of conflict between vehicles and vulnerable road users in Homezone streets.

Appropriate measures should be prescribed to make it abundantly clear to drivers that they are entering a Homezone environment. Such measures might include a pedestrian refuge zone, a change in surface treatment colour, in-lane Homezone roundels and / or Homezone gateway signage which could be installed at entry points.
